Causal Analysis of the FASB Uranium Silicide Compact Combustion Event

Level 1 Cause Analysis

ORPS Number: NE-ID--BEA-FASB-2013-0001

Event Occurred: April 10, 2013

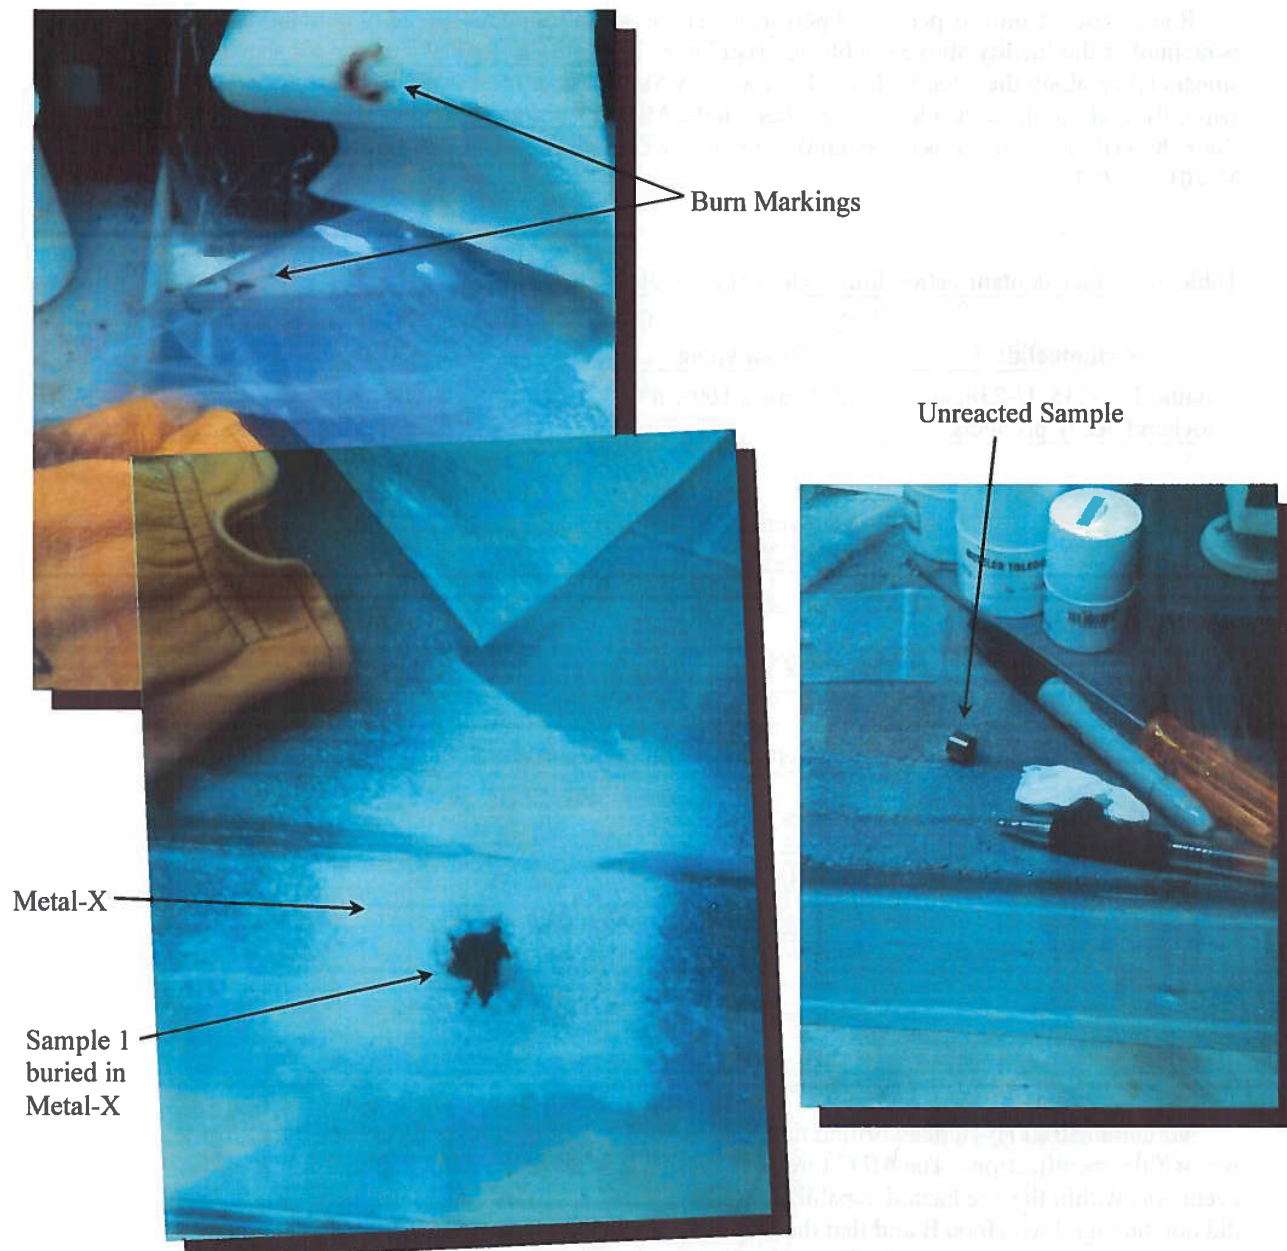
All subsequent actions taken were appropriate for this event and are detailed in the timeline for this event contained in Section 3.1. The MFC Fire Department found no presence of fire when they entered the facility and thermal imaging indicated that the combustion event was over and did not spread from Sample 1.

Figure 1 shows conditions approximately 5 hours after Sample 1 combusted. The pictures have been positioned to show the relative position of Sample 1 and other items within East Hood B. The unreacted sample shown in Figure 1 did not indicate a raised temperature during any thermal scanning by the fire department, either immediately after the event during radiological surveys of the facility or when the samples were transferred back to the RERTR Glovebox.

Figure 1. Post Event Pictures in Relative Position in East Hood B.

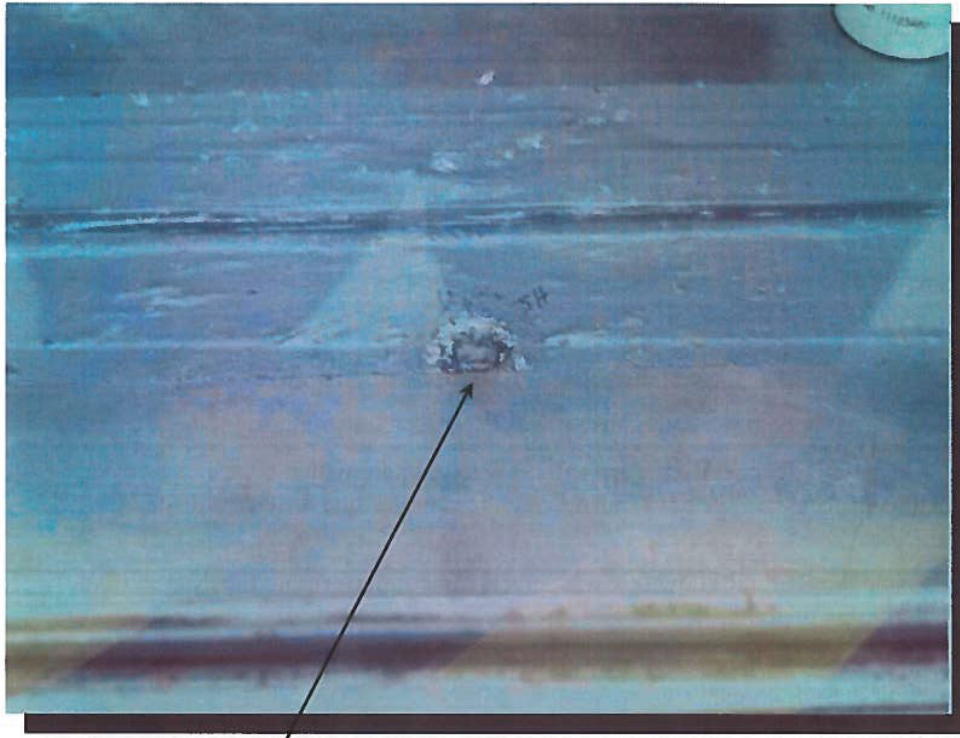
At 6:30 PM, the compacts and METAL-X were transferred to the RERTR Glovebox compartment C and FASB returned to normal operational status. Figure 2 was taken after the remains of Sample 1 and the Metal-X were removed and the area decontaminated. This picture shows the minimal damage to the standard duct tape that was in direct contact with Sample 1 while it combusted.

Figure 2. Minimal damage to duct tape in direct contact with Sample 1
